## Failure analysis of corrosion cracking and simulated testing for a fluid catalytic cracking unit

Hua Chen<sup>1)</sup>, Xiaogang Li<sup>1,2)</sup>, Chaofang Dong<sup>1)</sup>, Ming Li<sup>1)</sup> and Jinwen Yang<sup>3)</sup>

**Key words:** stress corrosion cracking; fluid catalytic cracking unit; dew point; failure

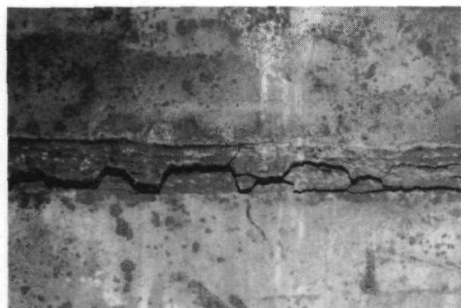
Many cracks at the outside of the welds were observed on the shell of the regenerator and the pipe of the ascending airflow. The pipe of the ascending airflow with cracks propagating from the inner surface to the outer surface of the wall was replaced (**figure 1**). The area of the pipe with high crack density was cut as samples, and the failure analysis and testing were conducted. The regenerator was made of Q235, and the pipe was 16MnR. The following examinations were performed on the failed pipes.

Figure 1 Cracks of FCCU.

The surface of FCCU components was found to be corroded slightly by visual examination and cracks were detected by using a magnetic powder crack detector. Cracks propagated from the inner surface to the outer surface, and some of them penetrated through the wall. There were much more cracks on the inner surface than on the outer surface. Most of them were along the traverse direction, and the maximum crack length was found to be 90 mm. These results were confirmed with ultrasonic detection and X-ray examination. Hardness measurements indicate that the hardness of base metal is normal, but the hardness of the weld and heat affected zone is comparatively higher than the normal value.

- Increase the temperature of the shell and wall of a regenerator above the fume dew point by improving the inner liner and the out thermal insulation layer.
- Add the transfer catalyst of nitrogen and sulfur.
- Use the material with low strength and high nitrate SCC resistance.
- Reduce the residual stress from assembling and welding by improving the technique of equipment fabrication and installation.
- Protect the components by using coating or some other electrochemical methods.

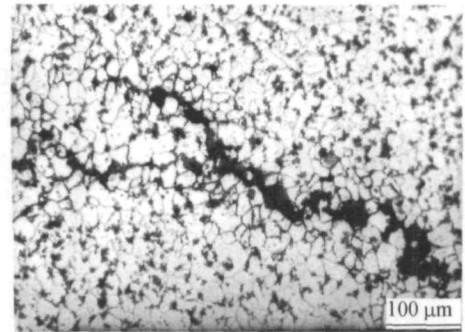
The microstructure of the weld is Widmanstätten structure, and the grain size is large. The microstructure gradually changes from Widmanstätten structure at weld to ferrite-pearlite texture at the base metal through the heat affected zone. Cracks were examined under an optical microscope (**figure 3**), and it was found that they were propagated from the inner surface to the outer surface, and then penetrated through

the wall. There was no obvious plastic strain at the locations of crack initiation. The cracks appeared narrow at the surface, but deep inside the wall. They mainly grew along grain boundaries with many branches, but some ferrites were found broken. The microstructure near the cracks was normal. SEM observations of the fracture surface (**figure 4**) showed brittle intergranular cracking characteristics, which implied the occurrence of stress corrosion cracking.

**Figure 3** Crack growth path of the FCCU.

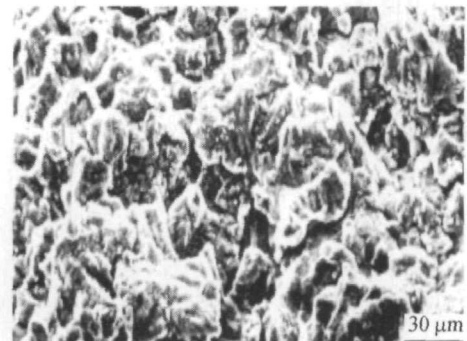
**Figure 4** Fractured surface by SEM.

There were many corrosion products formed on the fracture surface. X-ray diffraction shows that they are mainly Fe<sub>3</sub>O<sub>4</sub> and Fe<sub>2</sub>O<sub>3</sub>. The chemical composition analysis of the corrosion products was conducted, and the data are listed in **table 5**.

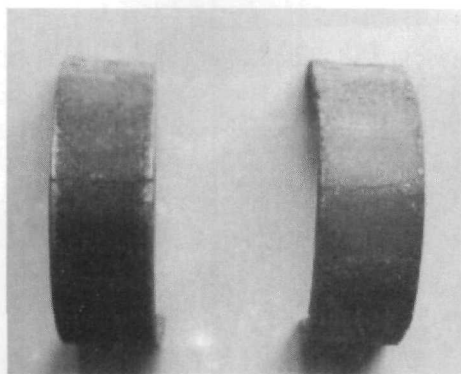
After 180 h, a crack was observed on the Q235-A weld specimen at the location with the maximum stress. The crack was perpendicular to the tensile stress direction (**figure 5**). After 500 h, no crack was observed on the other specimens. When the testing was finished, the fracture surface and microstructure of the Q235-A weld specimen were examined, and the results are shown in **figures 6 and 7**.

**Figure 5** Cracks on the simulated testing samples.

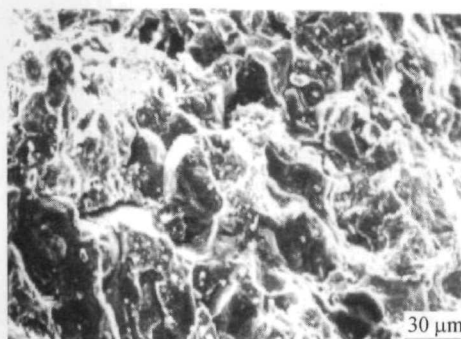
**Figure 6** Fractured surface of the simulated testing sample.

The comparison of the results from laboratory simulated tests and the failed component analysis showed similar characteristics on the fracture surface, corrosion products, microstructure, *etc.* This further confirmed that the failure of the regenerator in the FCCU was caused by nitrate SCC.

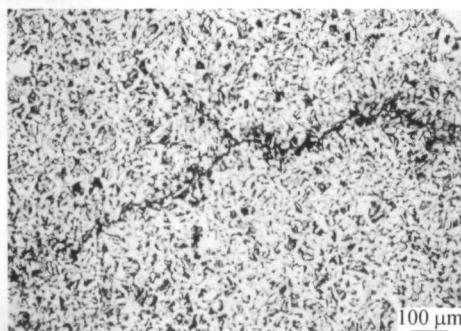
**Figure 7** Crack growth path in the simulated testing sample.
