## Comprehensive assessment on dynamic roof instability under fractured rock mass conditions in the excavation disturbed zone

**Abstract:** The damage process of fractured rock mass showed that the fracture in rocks induced roof collapse in Yangchangwan Coal Mine, China. The rock mass was particularly weak and fractured. There occurred 6 large-scale dynamical roof falls in the excavation disturbed zone (EDZ) with the collapsing volume of 216 m<sup>3</sup>. First, the field detailed geological environment, regional seismic dynamics, and dynamic instability of roadways were generally investigated. Second, the field multiple-index monitoring measurements for detecting the deep delamination of the roof, convergence deformation, bolt-cable load, acoustic emission (AE) characteristic parameters, total AE events, AE energy-releasing rate, rock mass fracture, and damage were arranged. Finally, according to the time-space-strength relations, a quantitative assessment of the influence of rock-mass damage on the dynamic roof instability was accomplished.

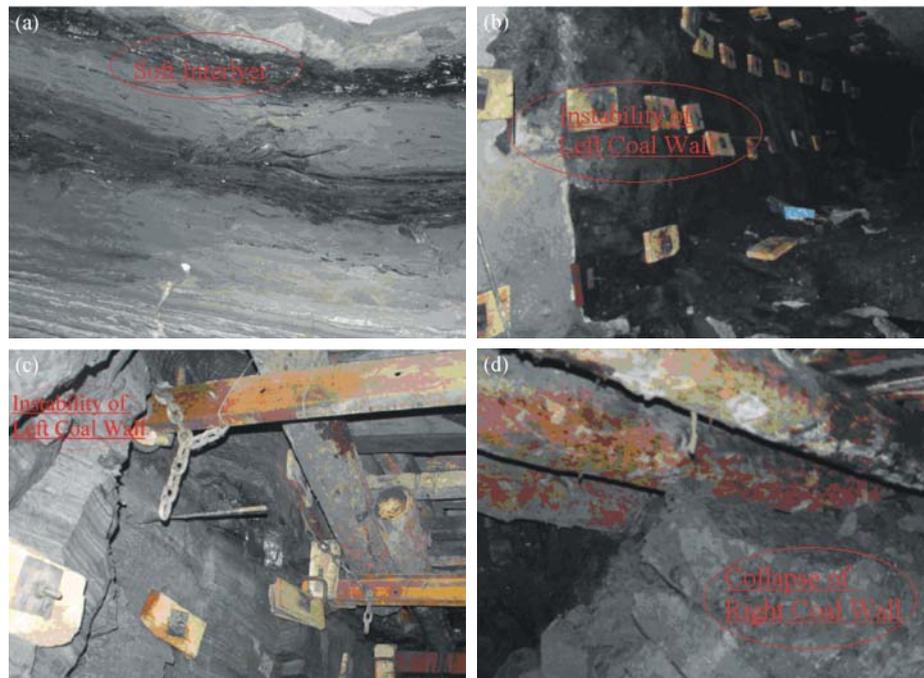
The mechanical strength of the left (Fig. 1(c)) and right (Fig. 1(d)) walls was deteriorated which induced

local falls with the maximum collapse volume of 216 m<sup>3</sup> on June 20, 2006.

**Fig. 1.** Photographs of field investigation: (a) soft interlayer; (b) instability of the left coal wall; (c) instability of the upper corner at the left coal wall; (d) collapse of the right coal wall.

loading conditions, the main mechanical strength of the left and right coal walls was deteriorated so as to pose unsymmetrical force and deformation. Ultimately, local falls were induced as shown in Figs. 1(c)-1(d).

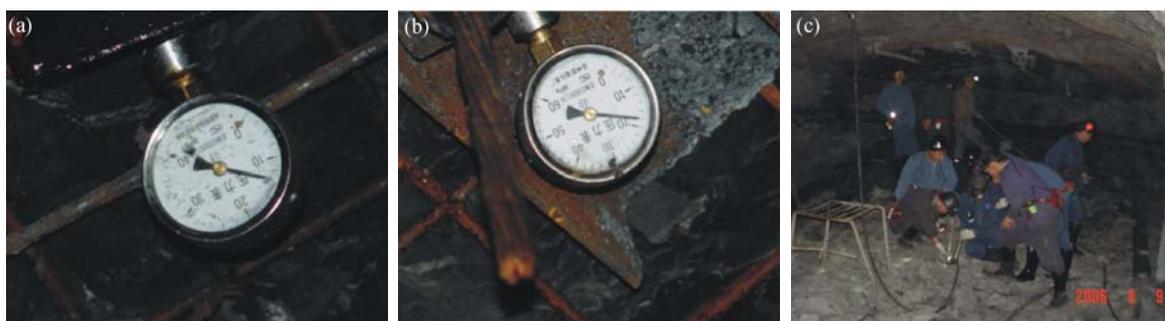
Rock bolts and cables are widely used in the field to maintain ground stabilization [3-4]. The anchorage quality, the loading status, and the bolt integrity are of most concern in the field. The rock bolt and cable work conditions or behaviors were evaluated through anchoring force test [5-10]. Using the MJ-40 bolt and MCJ-60 cable stress meters in the engineering field (Fig. 6), the anchoring strength of the roof-bolt cable and wall-bolt was increased during the monitoring period. The anchoring force of the roof-bolt cable and wall-bolt increased in 2006 (Figs. 7(a)-7(c)). The variable trends of the anchoring force of 1<sup>#</sup> cable were increased, with the force of 18.3 and 14.4 kN at 1<sup>#</sup> roof-bolt and 2<sup>#</sup> roof-bolt. The results clearly demonstrated that the temporal and spatial variation influ-

Fig. 6. Field monitoring anchoring strength: (a) 1<sup>#</sup> bolt; (b) 2<sup>#</sup> cable; (c) in-situ bolt pullout tests.
